# Casting Defect Analysis in Printing Machine Cylinders

**Abstract** — This paper deals with casting defects in offset printing press cylinder and their remedies. A printing press is a mechanical device for applying pressure to an inked surface resting upon a medium (such as paper or cloth), thereby transferring an image. Sand inclusion is one of the most frequent causes of casting rejection. It is often difficult to diagnose, as these defects generally occur at widely varying positions and are therefore very difficult to attribute to a local cause. Areas of sand are often torn away by the metal stream and then float to the surface of the casting because they cannot be wetted by the molten metal. Sand inclusions frequently appear in association with CO blowholes and slag particles. Sand inclusions can also be trapped under the casting surface in combination with metal oxides and slags, and only become visible during machining. If a loose section of sand is washed away from one part of the mould, metallic protuberances will occur here and have to be removed. In this paper sand inclusions were closely studied and two methods were proposed such as a gating system and mixing of sands.

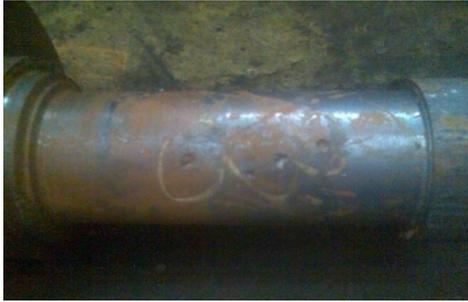
Fig.6 Diagram of blowholes

They are rough shaped holes occurring on the outside of casting or in the thicker sections. They may be found just below the surface on machining. In severe cases, section of casting may be hollow; cavities may be dull or bright depending on conditions under which they have formed. The various defects and remedies are discussed below

1. Insufficient permeability of molding or core sand.
2. Hard ramming
3. High moisture content, above 2.5%
4. Rusty or damp chills or chaplets
5. Very hard cores
6. Core and molding gases getting trapped
7. Improper baking
8. Damp pouring ladles
9. Too low pouring temperature, below 1150° C
10. Down sprue not full
11. Very fast pouring, pouring rate is 0.80kg/sec
12. Improper gating ratio

1. Increase permeability by use of coarser sand
2. Avoid excess ramming
3. Reduce moisture to minimum content with workability
4. Ensure the chaplets are dry and chills are free from rust. Use silicon carbide chills.
5. Avoid metal impinching chills by properly locating the gates.

6. Reduce oil in core sand.
7. Take out the core properly. Mould gasses should be allowed to go out properly by increasing mould vents.
8. Ensure proper baking of cores and moulds. Check mould dryness.
9. Dry thoroughly all pouring ladles.
10. Increase pouring temperature
11. Use large pouring basins
12. Pour correctly
13. Correct gating ratio

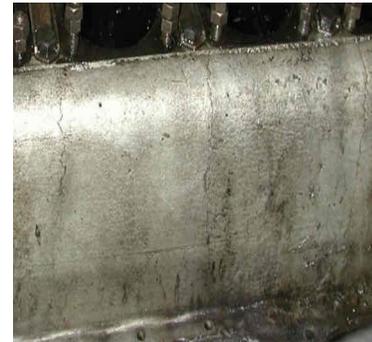
Fig.7 Diagram of cracks

Hairline cracks shown in Fig. 7. When broken, discoloration shows that crack was produced while casting was hot. No discoloration shows cold crack. The various defects and remedies are discussed below

1. High dry strength (45kg/mm<sup>2</sup>), poor collapsibility
2. High pouring temperature(1150°C)
3. Superheated metal
4. Uneven cooling due to section variation
5. Improper feeding
6. Early knock out
7. Wrong composition
8. Sharp corners

1. Reduce dry strength, add saw dust/ coal dust
2. Reduce pouring temperature
3. Avoid superheating of metal
4. Use chills
5. Provide feeders
6. Avoid early knockout. Give sufficient cooling time.
7. Correct composition
8. Reduce sharp corners

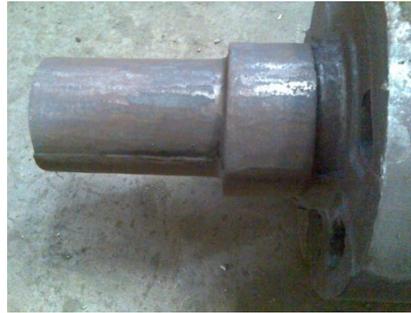
Fig.8 Diagram of mismatch shift.

It is shift in the casting along the parting line. The various defects and remedies are discussed below.

1. Pattern shift
2. Box shift

1. Check pattern mounting on match plate and rectify, correct dowels.
2. Use proper molding box and closing pins.
